VAILLANCOURT FOUNTAIN CONDITIONS ASSESSMENT

SAN FRANCISCO, CALIFORNIA
[24146A]

PREPARED FOR
San Francisco Recreation and Park Department

June 2, 2025

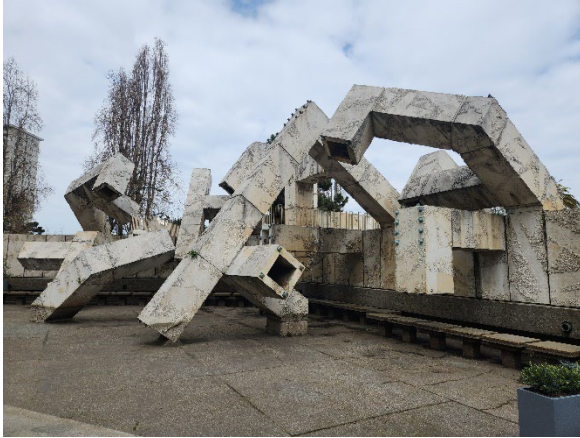
Overall view of fountain, particularly the hollow, pre-cast concrete "arms," looking north.

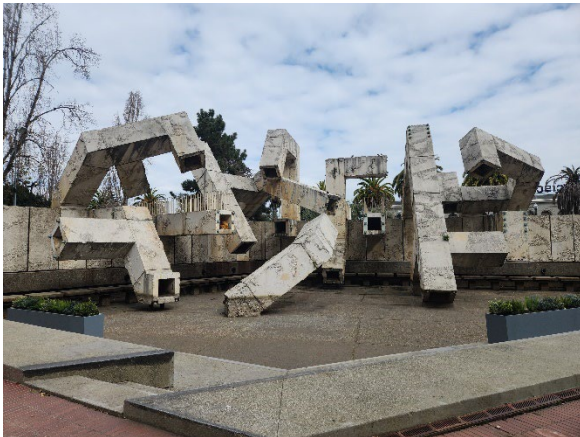
Overall view of fountain, particularly the hollow, pre-cast concrete "arms," looking northeast.

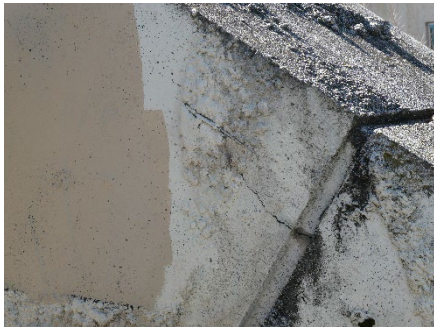
Incipient spalling at upper joint of projecting column. Typical condition.

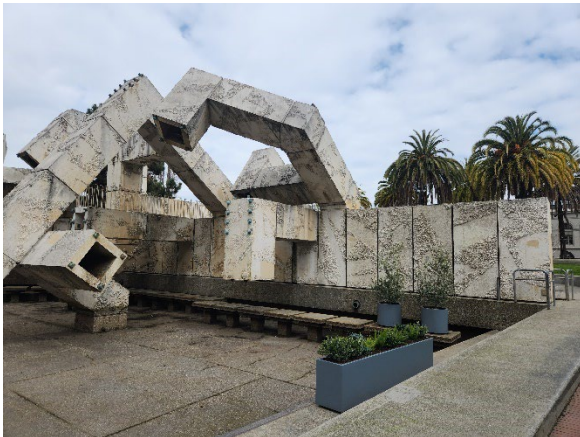
Overall view of the hollow, pre-cast concrete panel wall, east side of fountain looking northeast.

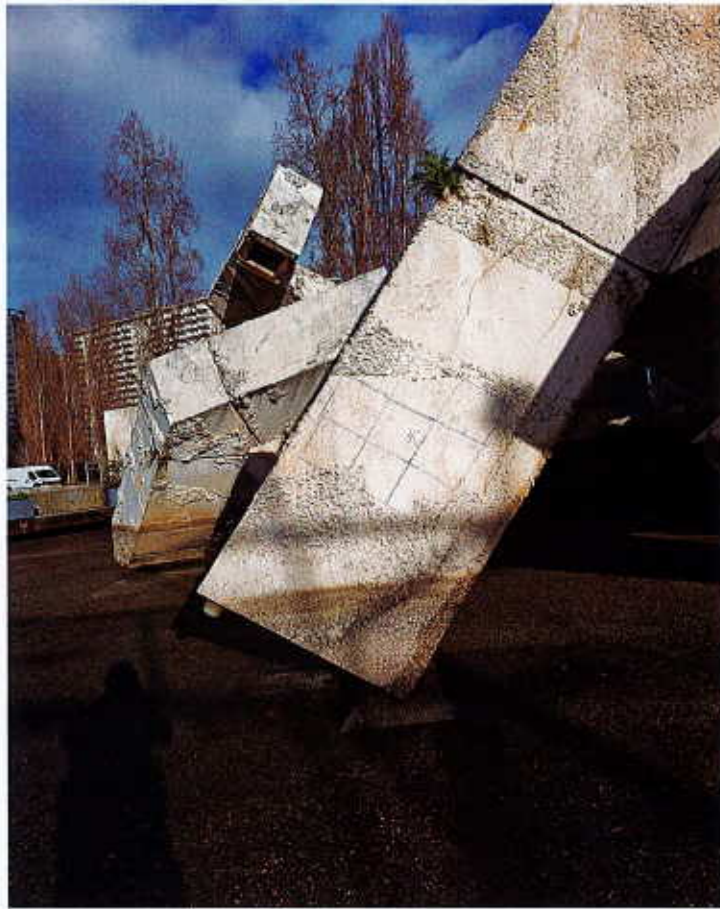
Photo 1. Side view of one of the tubes with GPR scan markings on the face of the tube.

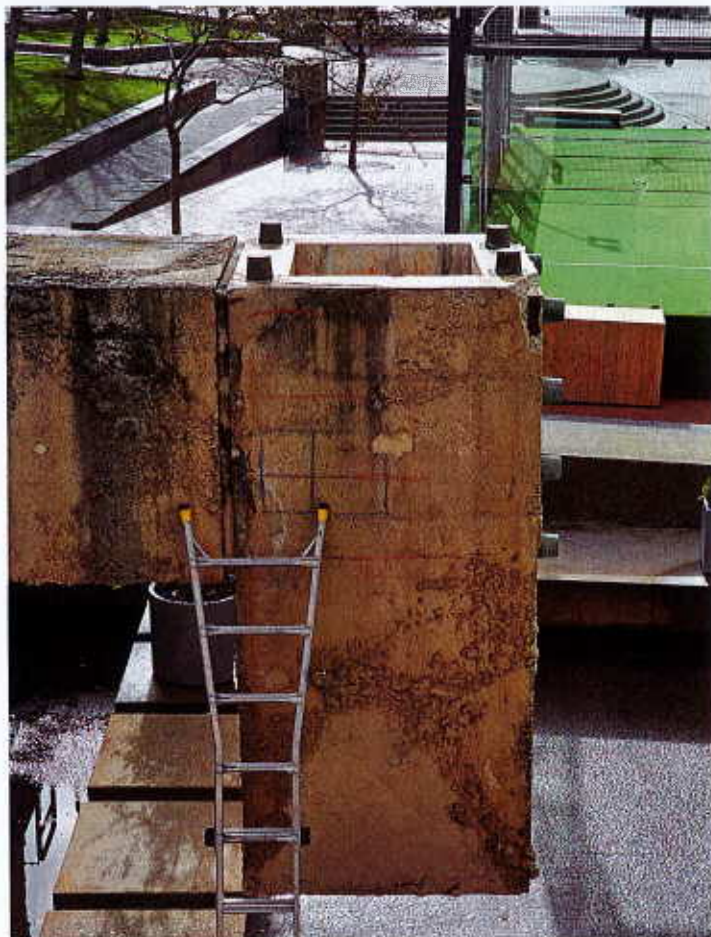
Photo 2. Red GPR scan markings indicate a rod of an unknown material connecting the tubes.

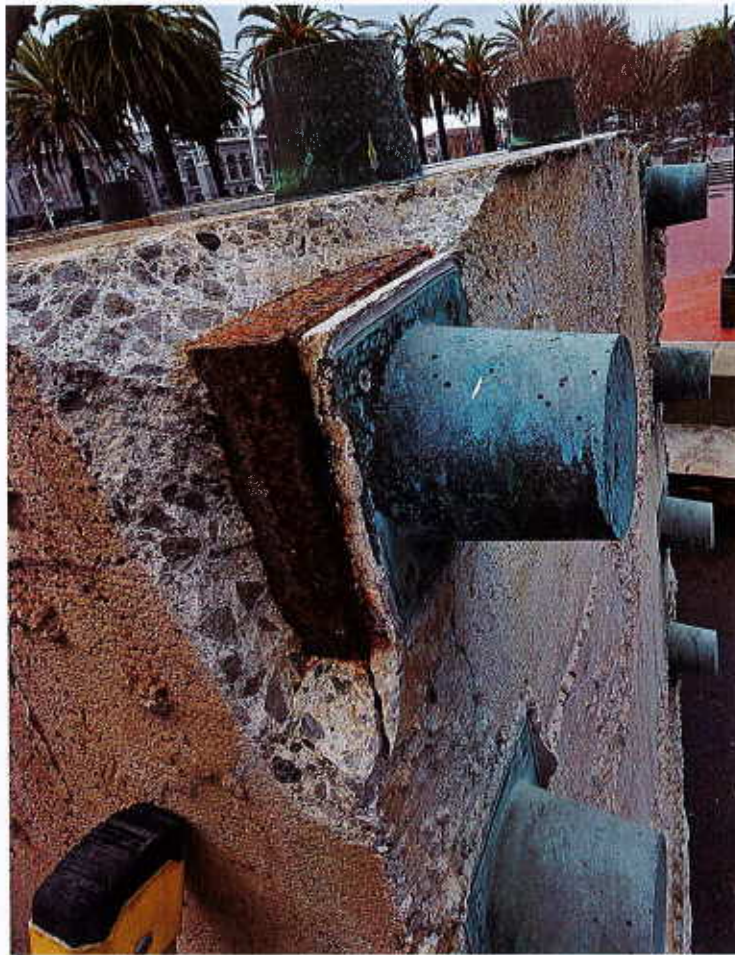
Photo 3. Steel plate at end cap.

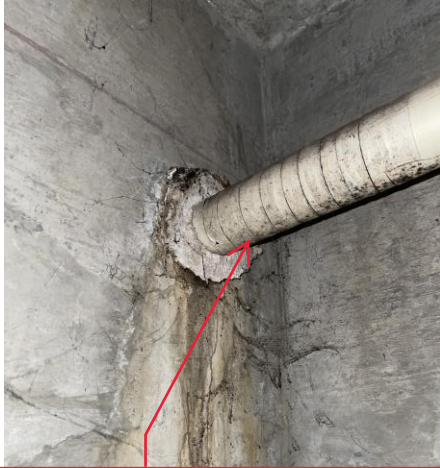
Photo # 1

Description: ACM¹ Pipe Insulation at Pump Room Closet

This is the only area where ACM pipe insulation was identified. This insulated pipe run exits the room through a wall opening, presumably to the exterior underground area)

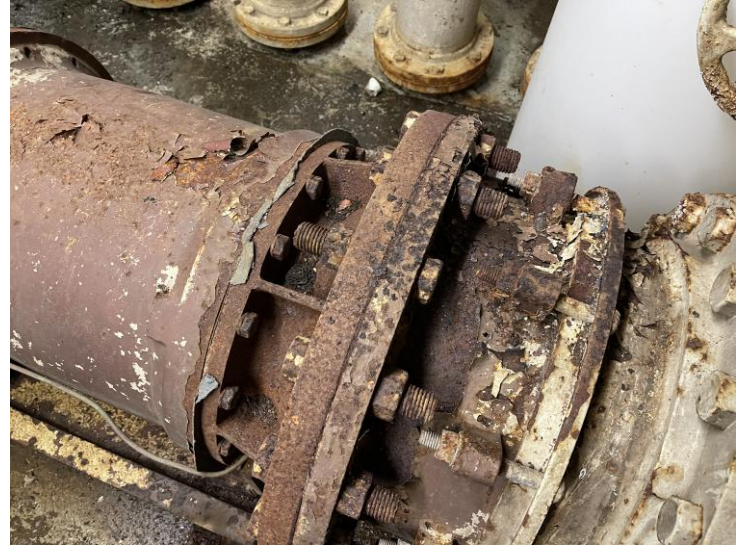
Photo # 2

Description: ACM¹ Pipe Gasket and Multiple LBP² Surfaces at Main Pump Room

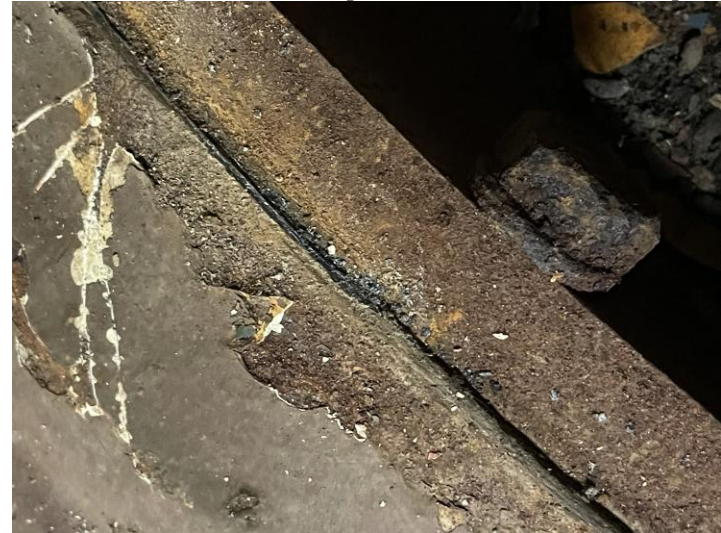
Photo # 4

Description: Close Up of ACM¹ Pipe Gaskets at Main Pump Room

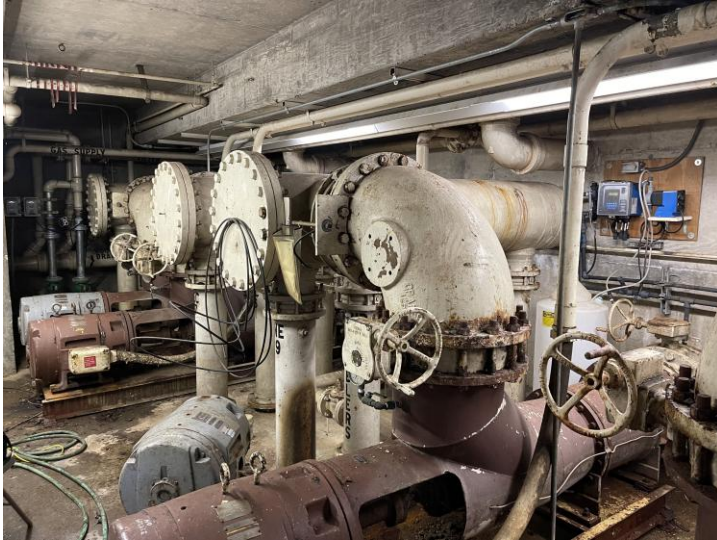
Photo # 5

Description: ACM¹ Gaskets at Pipe Flanges and Caps, LBP² and LCP³ Surfaces Throughout Main Pump Room

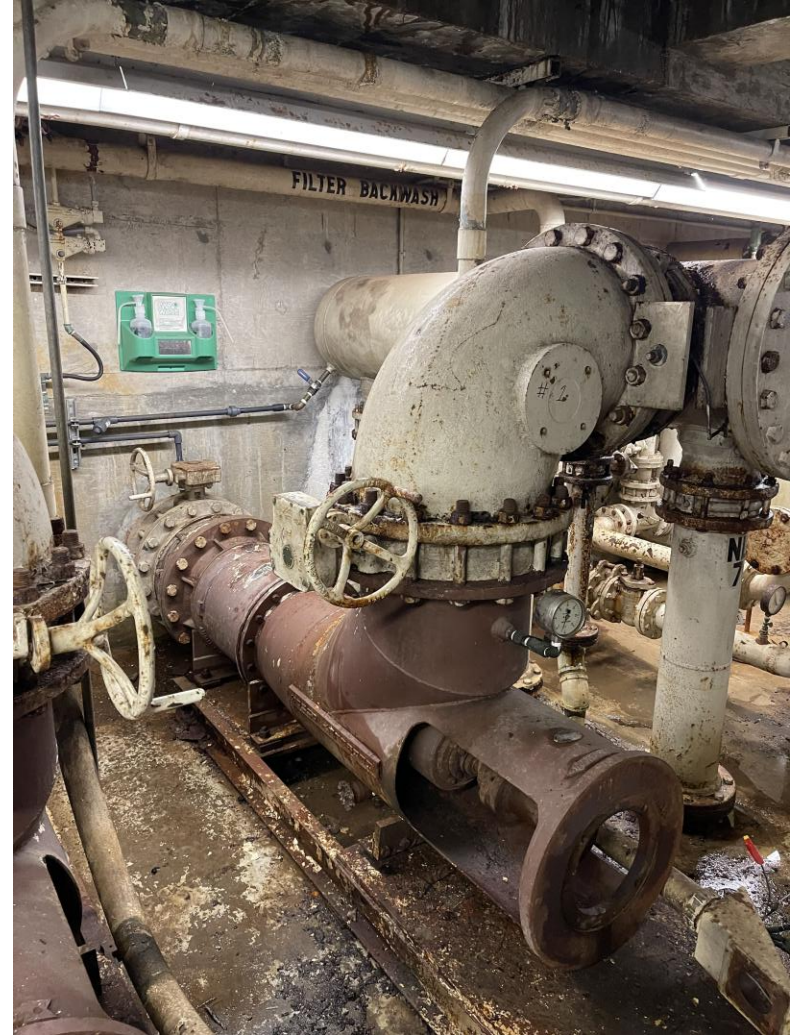
**Photo # 6**

Description: ACM¹ Gaskets at Pipe Flanges and Caps, LBP² and LCP³ Surfaces Throughout Main Pump Room

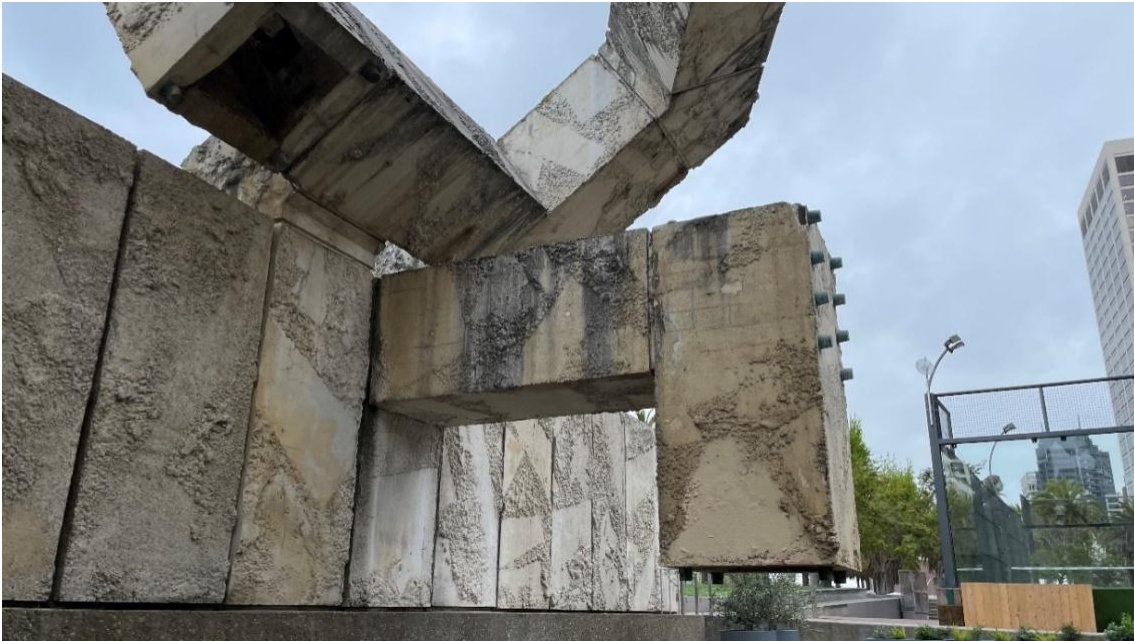
Protruding, cylindrical caps are observable at the ends of most precast concrete tubes and designate anchor locations of the steel tension rods. In locations where these anchor caps are damaged or missing, embedded steel pipes can be seen running longitudinally through the precast concrete tubes (reference *Figure 5* through *Figure 7*).

Figure 5: Vaillancourt Fountain - Cantilevered Elements Showing Tension Rods and Caps

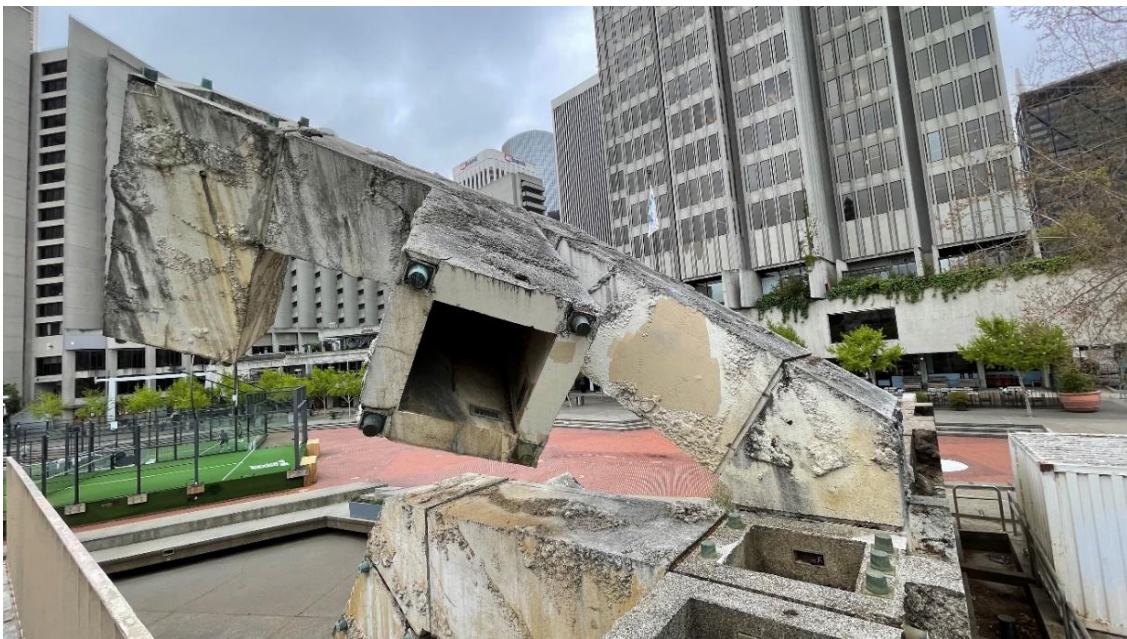
Figure 6: Vaillancourt Fountain – Cantilevered Elements Showing Tension Rods and Caps

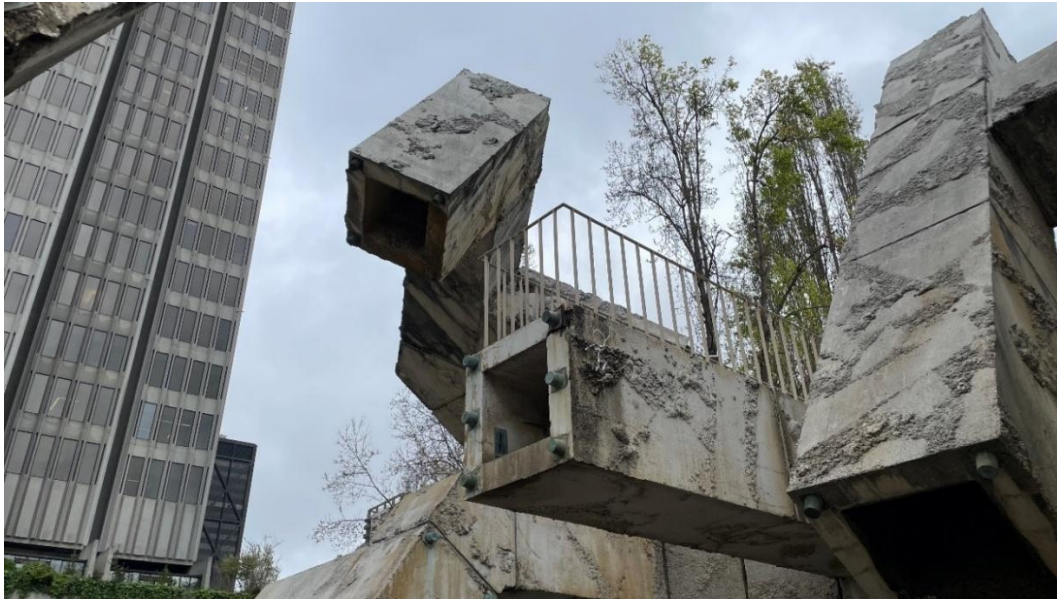
Figure 7: Vaillancourt Fountain - Cantilevered Observation Deck and Fountain Elements.
